Church of St Nicholas, Fundenhall, Norfolk

**Record and Analysis Report into the
Tower, Tower Roof and the South Nave Roof**

June 2007

Report into the Tower, Tower roof and the South Nave Roof

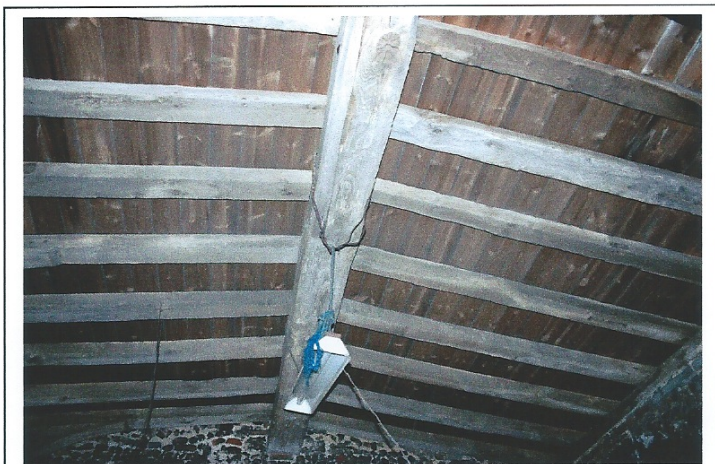
Fig 12: Detail of belfry ceiling

Contrary to his usual practice Phipson was content for the **belfry roof** to be restored rather than replaced outright: 'Properly restore as far as required the timbers of the Tower roof and boarding', but the trapdoor was to be left perfect, and in fact direct replacements were made in the case of the majority of the rafters. The architect had anticipated in his drawings of eighteen months earlier that

twelve new paired rafters would be necessary, but in the event this was not done. There is an east-west square chamfered raised beam with run-out stops from the mid 18th century, almost certainly inserted when the work to the bell frame was done in 1754 (see below), and there is an area of repair towards the west end of the early 19th century²³. Nine rafters either side are laid flat, the centre and outer ones with 18th century arched braces bedded directly into the masonry, and of these rafters the western two on the north side and No. 3

(from the west) on the south side are of c. 1754, while the remainder are of Phipson's time. Over these is boarding of 1869 and over that lead sheets of the same date: 'cover the whole with 7lb milled lead 2½" rolls not more than 3 ft 6 inches apart and lead flashing 10" wide all round parapet let into walls'. The contractor used seven sheets of lead, although the work does not lend the roof any particular architectural merit.

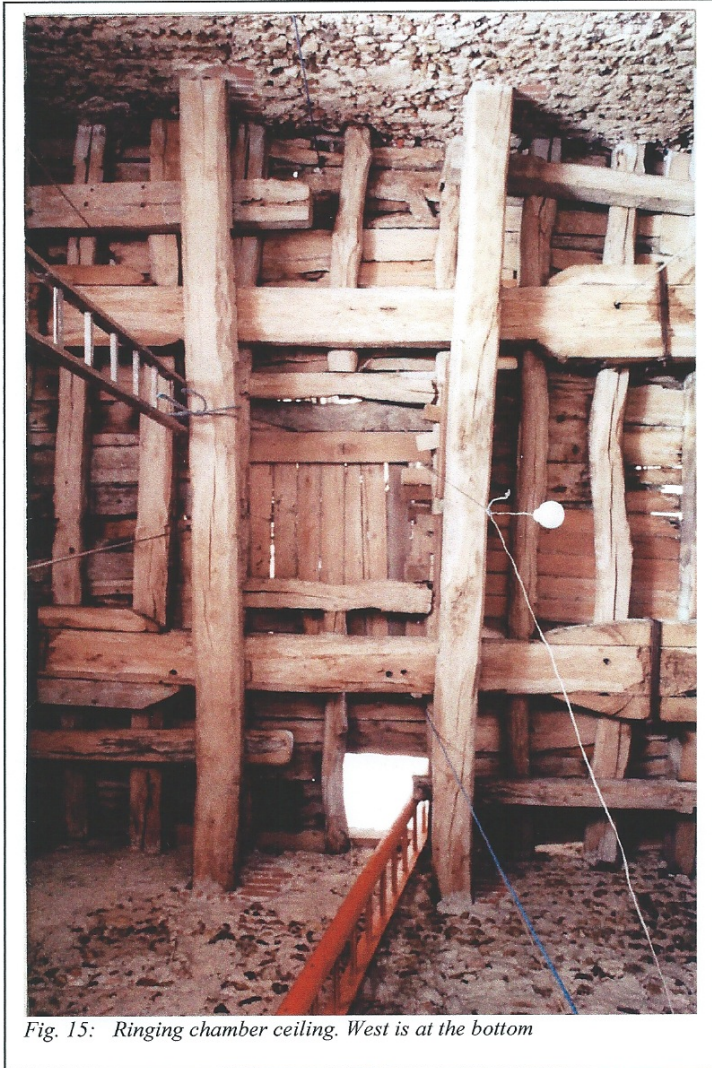
Fig. 15: Ringing chamber ceiling. West is at the bottom

principals, and in the centre is the hatch for bell-lowering, while the ladder access is by means of an opening at the west end of the centre bay. Various wedges have been driven between the boards and the cross beams in an effort to stabilise the structure, but it remains decidedly unsafe²⁴.

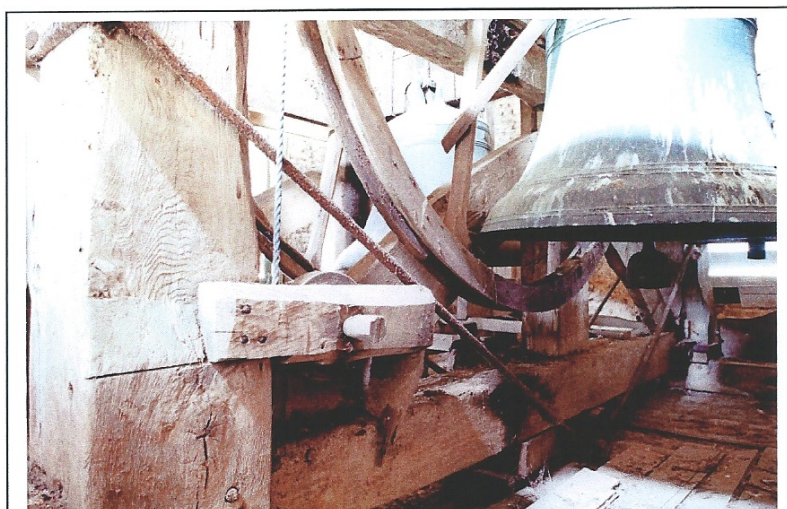
Fig. 16: The bell frame, centre pit, north truss. A Lester & Pack 1754 bell in foreground

There are two known dates for work to the tower - 1273, when the then rector was obliged to carry out repairs at his own expense, and in 1418, when it is highly likely that the pre-1869 belfry stage was built and three bells installed, complete with their **bell frame** which sits on the belfry floor of the same date (the belfry floor and the ringing chamber ceiling are of course the same structure). The bells themselves contribute to this chronology, and it is an interesting story. In 1552 there were still three bells, weighing 8 cwt., 10 cwt. and 12 cwt., but their weight was causing concern to the extent that in 1754 the churchwardens sought a Faculty to melt down the two heaviest to make four smaller bells, retaining the treble bell as a tenor²⁵. Bell No. 3 is attributed to Robert Brasyer who was active between 1377 and 1435, but it was only brought to Fundenhall in 1981 from Fornsett St Mary. The tenor bell however (No. 5) which survived the 1754 recasting is signed by Richard Baxter (active from 1416 to 1457) and is an important early

example of his work. As it happens the heaviest bells were not actually melted down at all, but moved to Kenninghall and four entirely new bells commissioned for the Fundenhall tower, all of them signed and dated 1754 by Thomas Lester and Thomas Pack of London²⁶. The upshot of this is that the 1418 bell frame was made for a ring of three (one of which is still *in situ*) and had to be altered in 1754 to provide more

space by means of narrowing the central pit from the south to take two small bells with another two hung in the south pit. Nevertheless the frame is very much in an intact early 15th century condition with the addition
